# Laboratory Furnace Fire

## Lessons Learned: Laboratory Furnace Fire

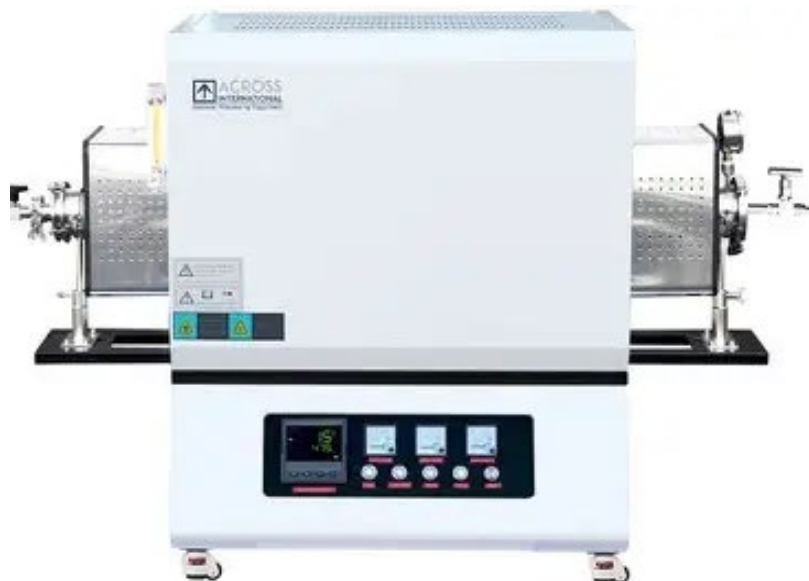
An Across International TF Series Tube Furnace, single-zone configuration with one Silicon dicarbide heating element (rated for up to  $1400 \pm C$ ) and equipped with a Eurotherm 3204 controller is at the centre of this incident (pictured below). The furnace was desk mounted, noting external dimensions of approx. 610 x 490 x 660 mm, and powered via a 240V supply.

This was confirmed by the forensic investigator's report whose opinion was that the probable cause of the fire was a sudden, high-energy mechanical rupture inside the furnace. The alumina tube (the internal containment vessel) fractured, releasing pressurised argon and ejecting hot components. These hot items landed in combustible materials near the western wall, which then ignited. It was noted that the expelled bimetal sample (Mn8/SS400) was operating at around  $900 \pm C$ , far above the auto-ignition temperature of cardboard and plastics ( $200 \text{ to } 450 \pm C$ ).

1. The alumina tube failed by brittle fracture due over pressurisation.
  - a. An overpressure event occurred in a hot, constrained alumina tube, which per the OEM manual warning can cause catastrophic tube fracture. The tube remained intact in this pressure until the combined thermal and mechanical stresses caused it to shatter.

The forensic investigator's opinion was that a slow leak from an isolation valve allowed pressure to build unchecked in the ceramic tube. This blowout posed a severe risk of injury or fatality to anyone near the furnace front.

- A. Pressure Safety: Install a low-set PRV/PSV ( $\leq 3$  psi gauge) and add a pressure transducer with interlock to inhibit heating if pressure rises.
- B. Monitoring: Continuous gauge + digital logging, with alarm and automatic isolation on overpressure.
- C. Configuration: Confirm non-return/check valves, vent paths, and purge procedures; perform leak checks prior to each run.
- D. Documentation: Finalise and maintain the Gas P&ID, operating SOPs, and training records.
