Emerging Property Risks & Building Resilience

Emerging Property Risks and Building Resilience

2026 Unimutual Conference

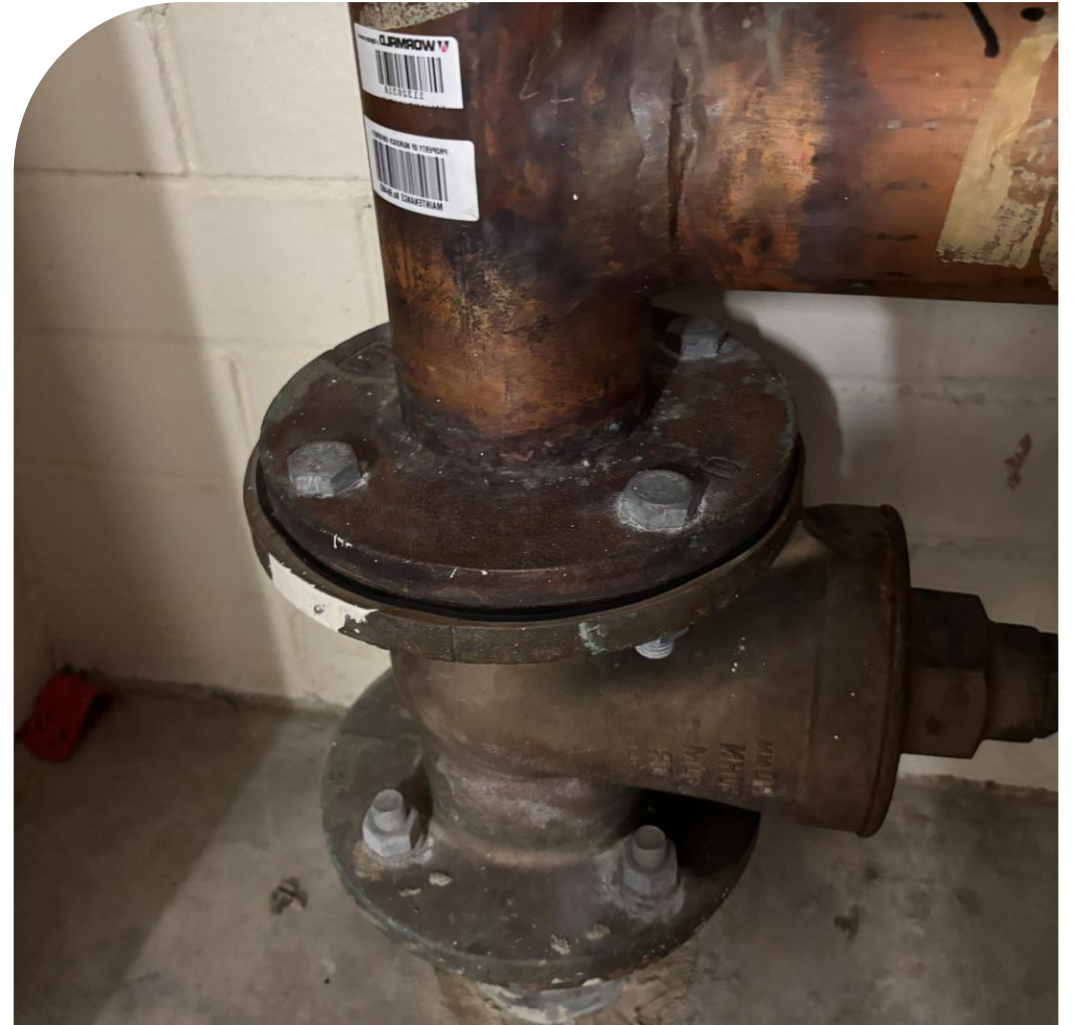
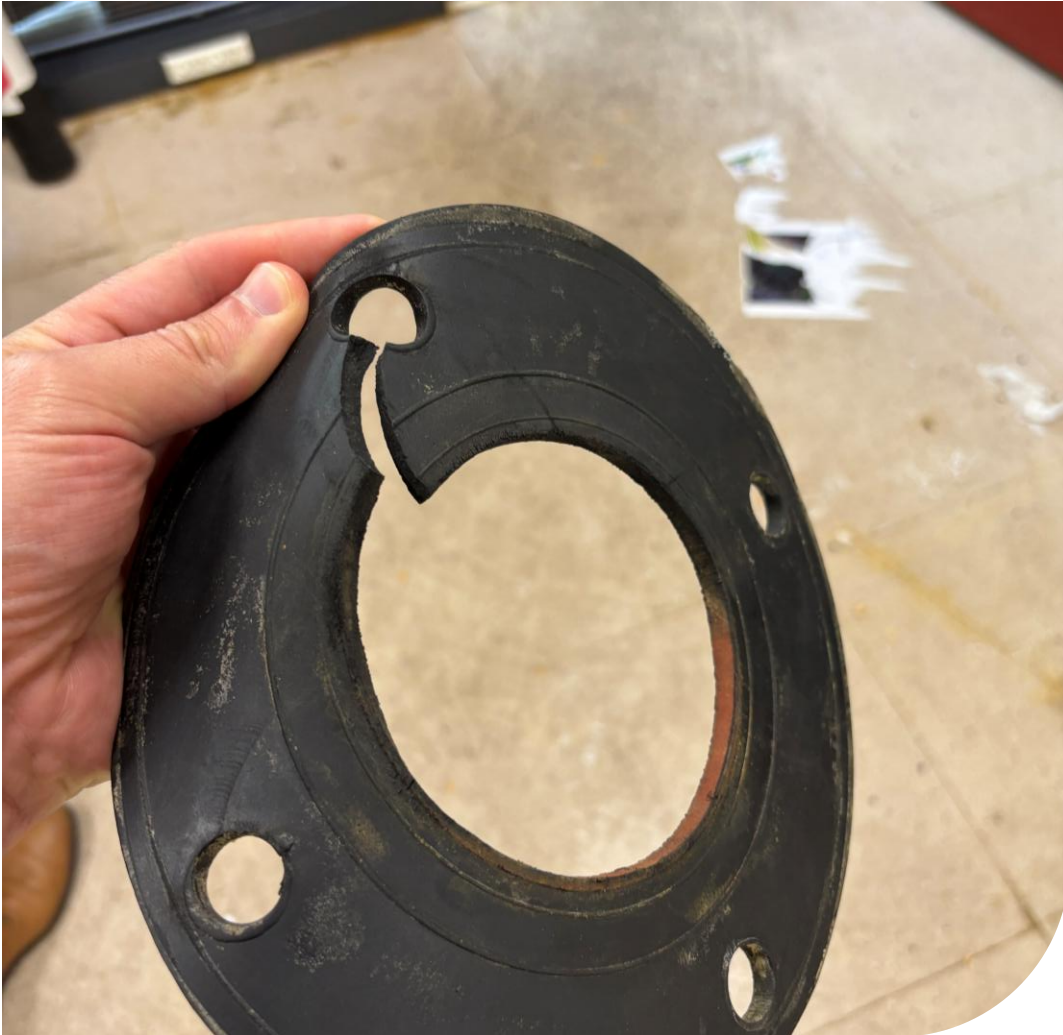
Fire Hydrant Failure in December 2025

Flange seal ruptured, causing substantial water discharge and significant water damage.

The hydrant was serviced quarterly, but this did not involve disassembly to check the seal.

Ruptured seal

The lack of external evidence that a failure was imminent, combined with the limited scope of the regular servicing, indicate that there are no third-party recovery prospects.

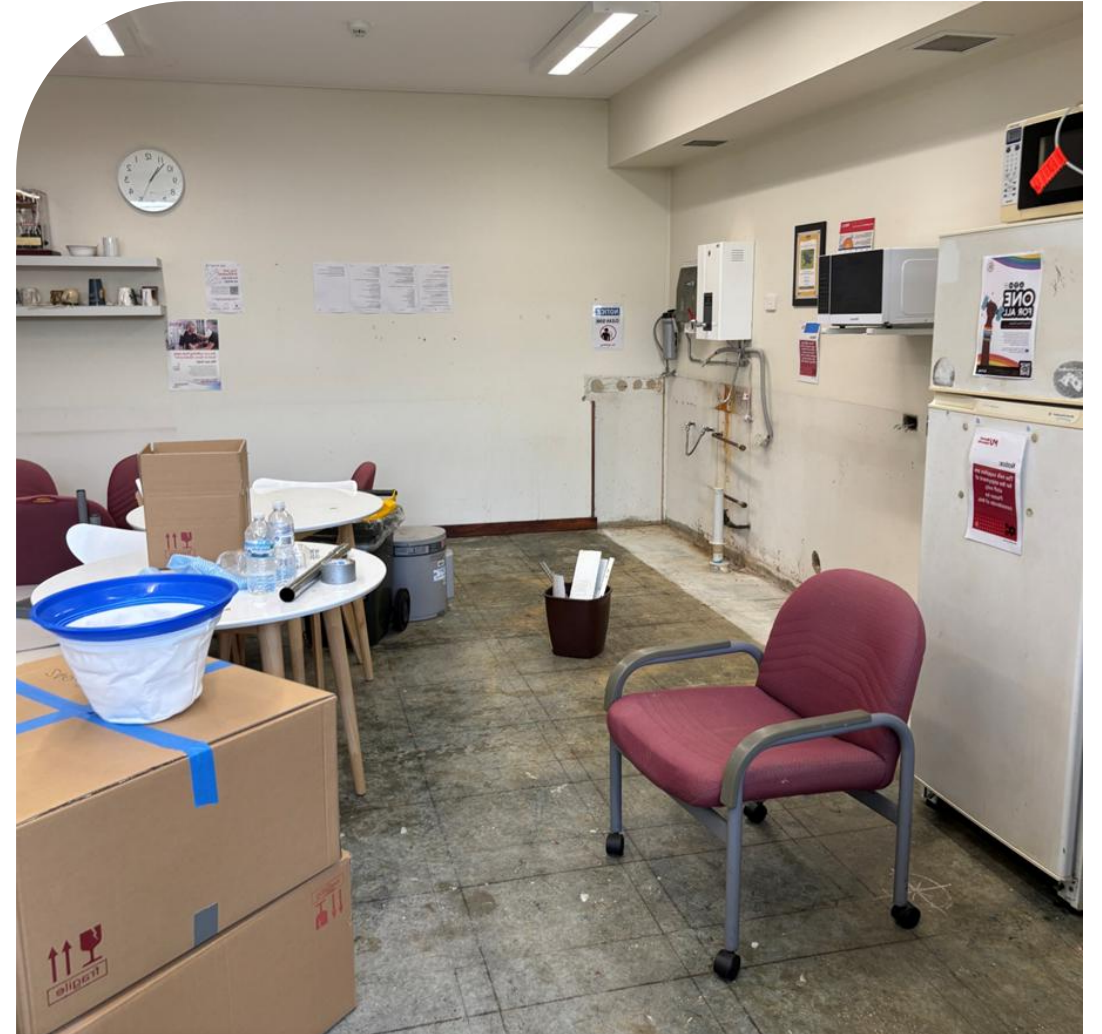
Fire Hydrant Failure - continued

Extensive water damage

- Damage to two levels of the building
- Damage to electrical switchboard
- Lift pits filled with water
- Damage to carpets, cabinetry and general contents
- Scientific equipment largely undamaged
- No Business Interruption claim at this stage
- Total incurred value of claim is \$600,000

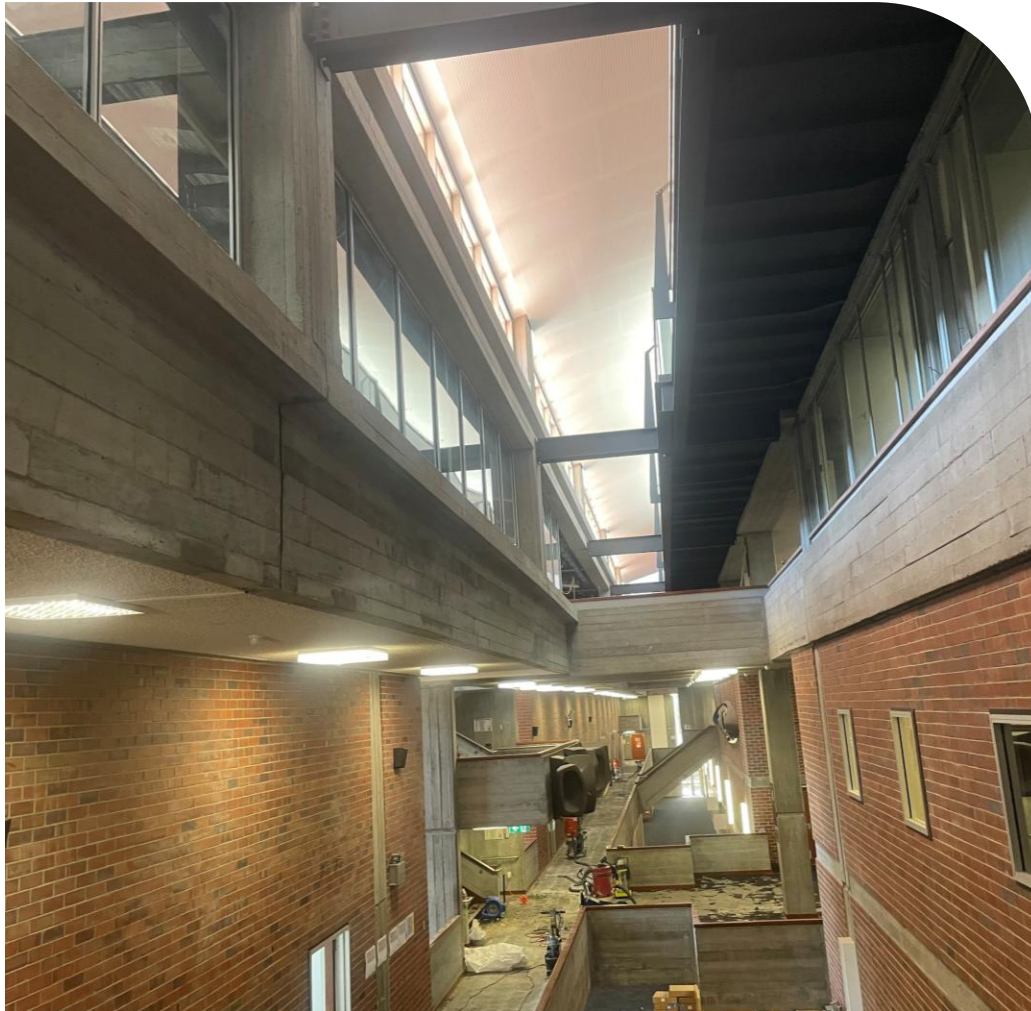
Box gutter overflow

- Building has a central concrete box gutter, running the length of the building (about 110 metres).
- Outlets to downpipes about 50mm up sides of gutter.
- History of water ingress issues due to failure of copper membrane.
- Member decided to install a siphonic drainage system, which is far more efficient than conventional downpipes.
- The work involved 48 penetrations to the base of the box gutter.
- During the work, the original downpipes were sealed, meaning that there was effectively no roof drainage.

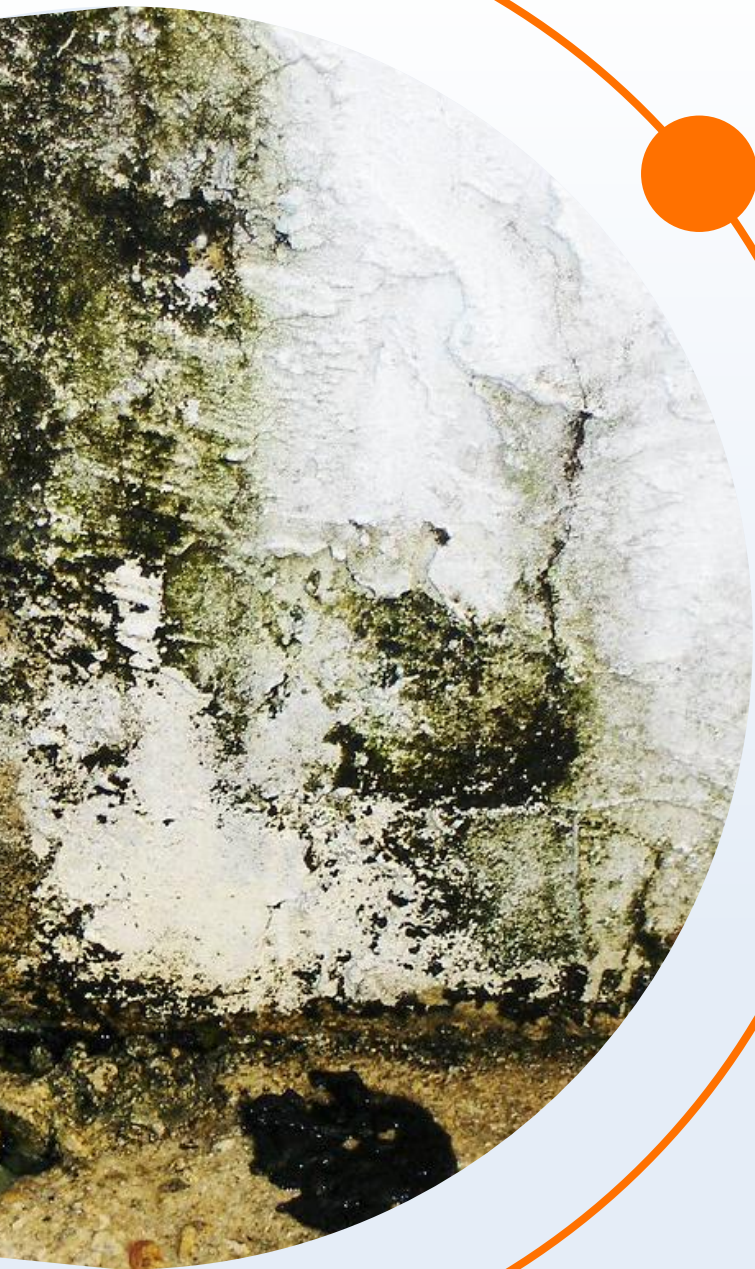
Box gutter overflow - continued

- On Friday 12 December, the contractor was alerted that light rain over the weekend was forecast.
- The Member and contractor calculated that the sealed box gutter could hold 18,000 litres of water.
- On Sunday 14 December, a severe thunderstorm occurred, involving 40mm of rainfall and about 125,000 litres of water landing on the roof.
- Significant flooding across four levels of the building.
- Total incurred value of claim is \$575,000.
- A recovery against the contractor is being explored.

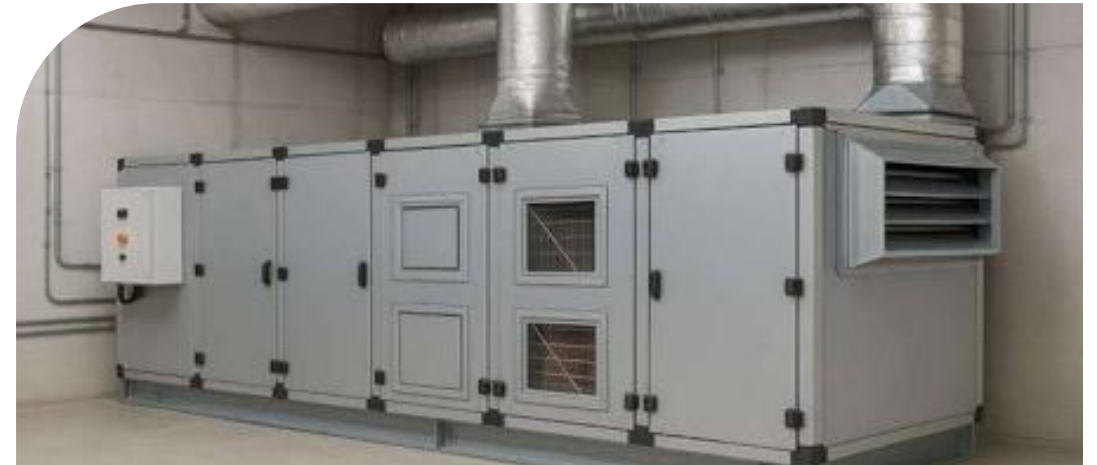
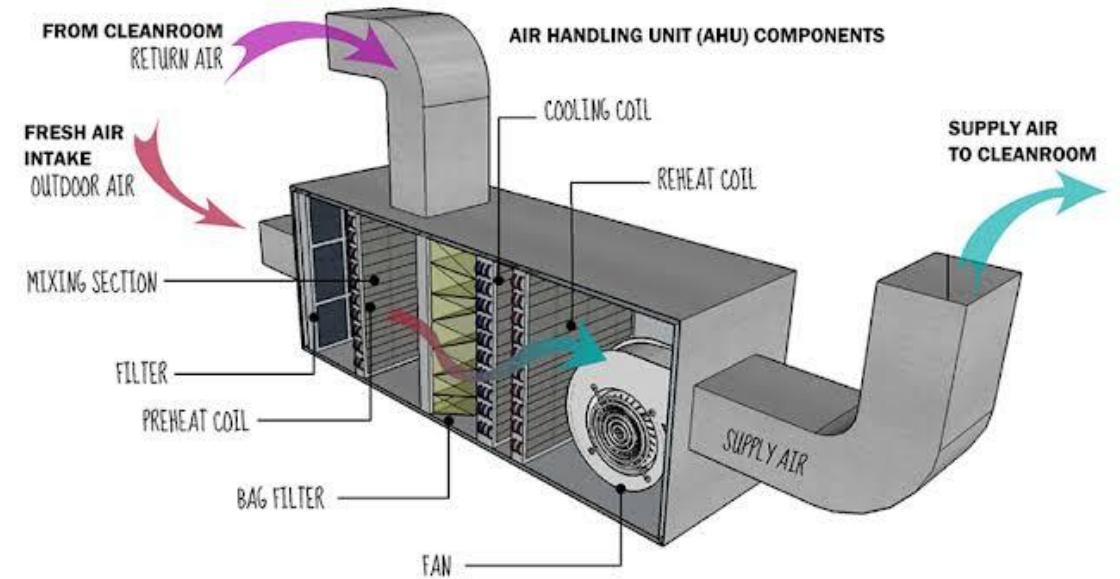
Mould – Case Study

Failure of Air Handling Unit

- Failure occurred over Christmas/New Year period in 2025-6
- Resulted in increased humidity while staff were on leave
- This led to significant mould growth.

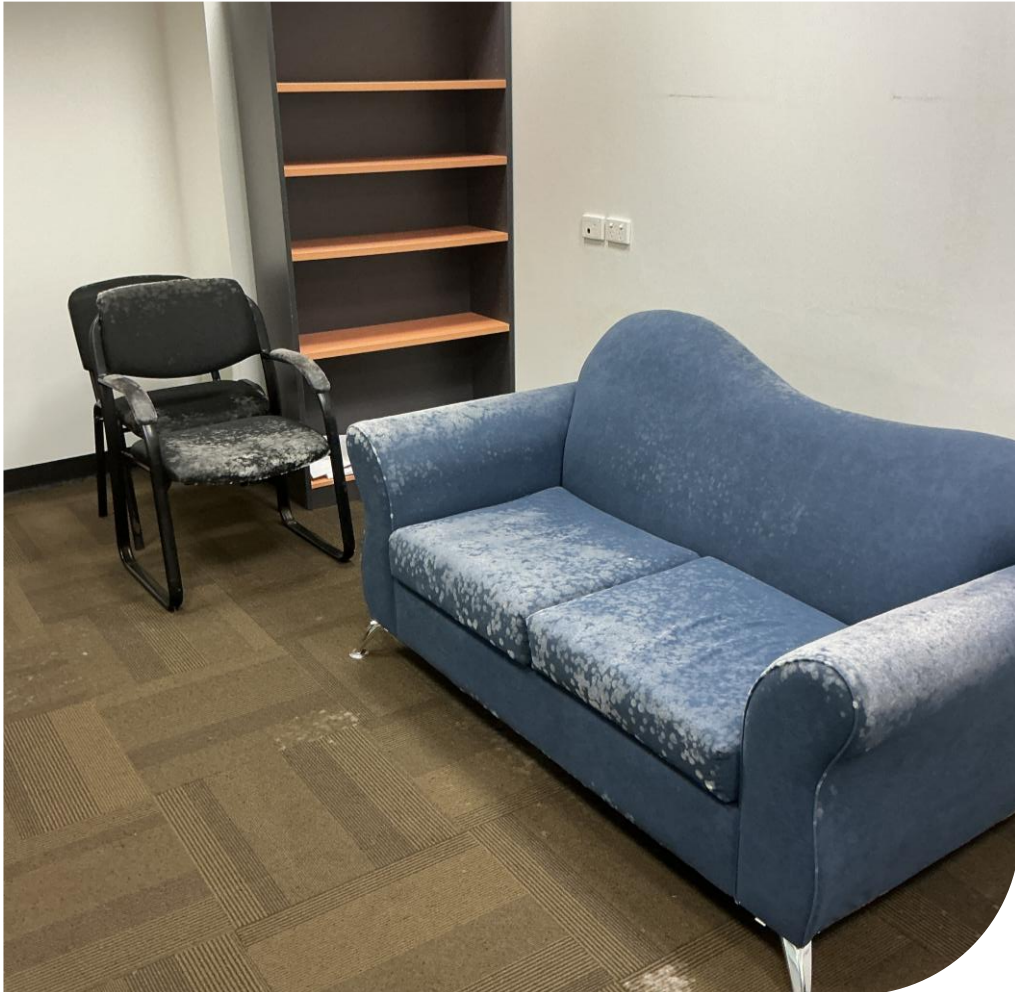
Coverage considerations

- Mould growth on carpets, furniture, ceiling tiles, walls and doors
- Mould remediation costs covered because breakdown of air handling unit is covered
- Initial estimate of mould remediation is \$60,000.
- Mould is not covered under the Property protection if there is no covered event but may be covered under the Environmental protection.

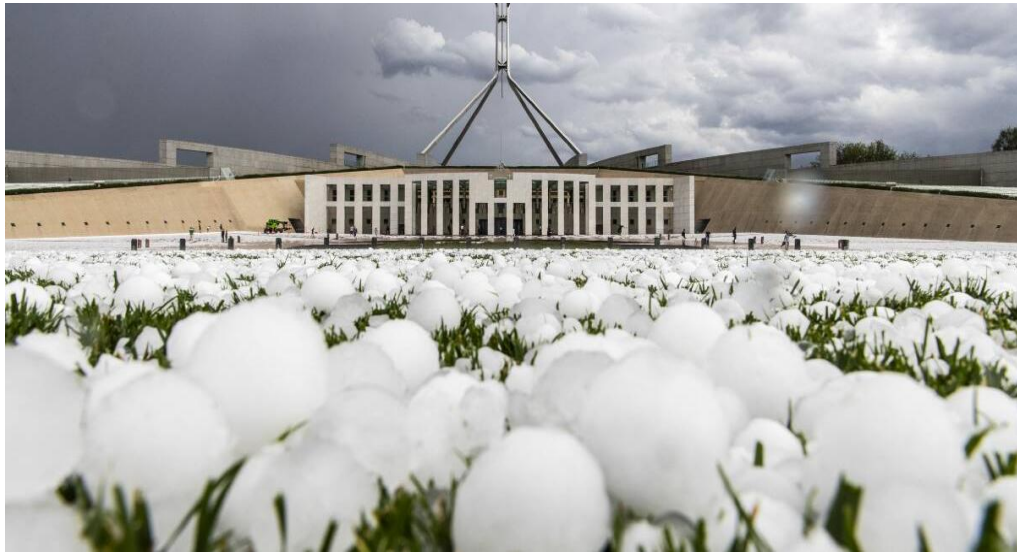
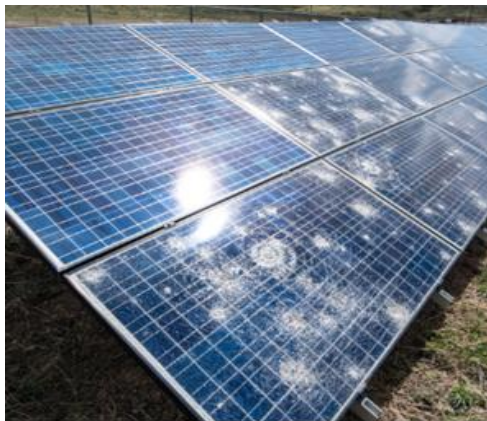
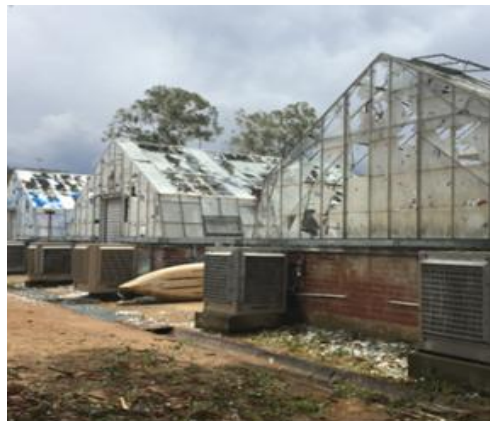
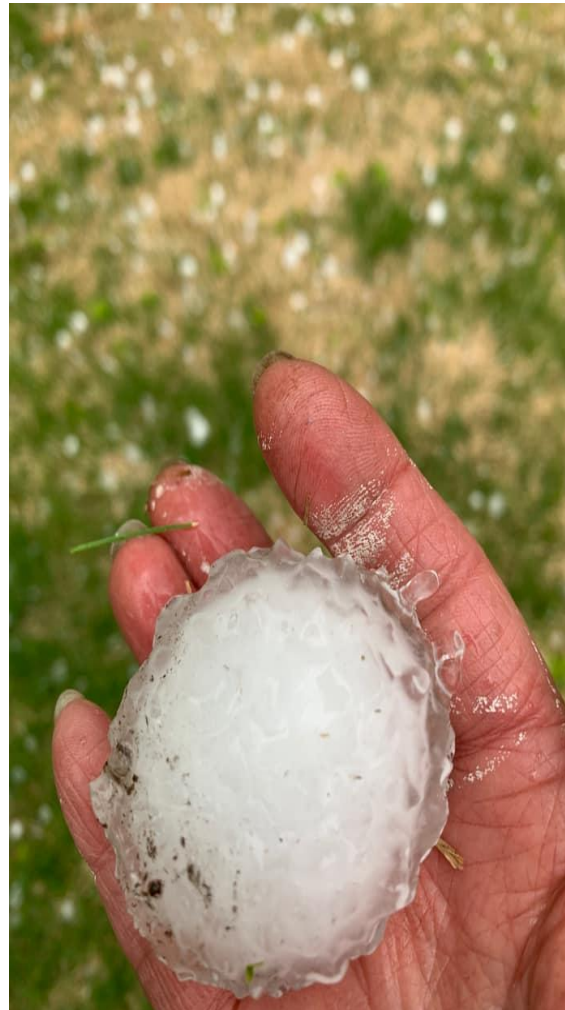
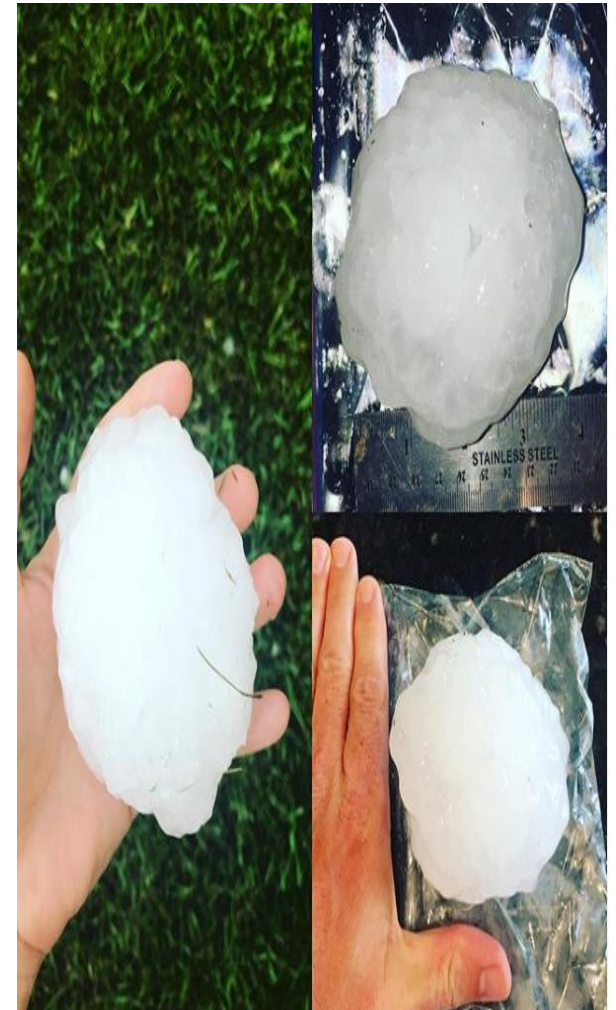
Hail is Getting Bigger

Convective storms are becoming more intense and hail is getting bigger.

Unimutual and TEFMA have engaged the CTS at JCU to undertake material damage threshold testing on a range of materials commonly used across college and university campuses.
