Addressing Mould Challenges in Southeast Queensland's Universities

Simplifying Mould Minimisation at UQ

UniMutual Conference
2026

Managing Mould after the 2018 flood event

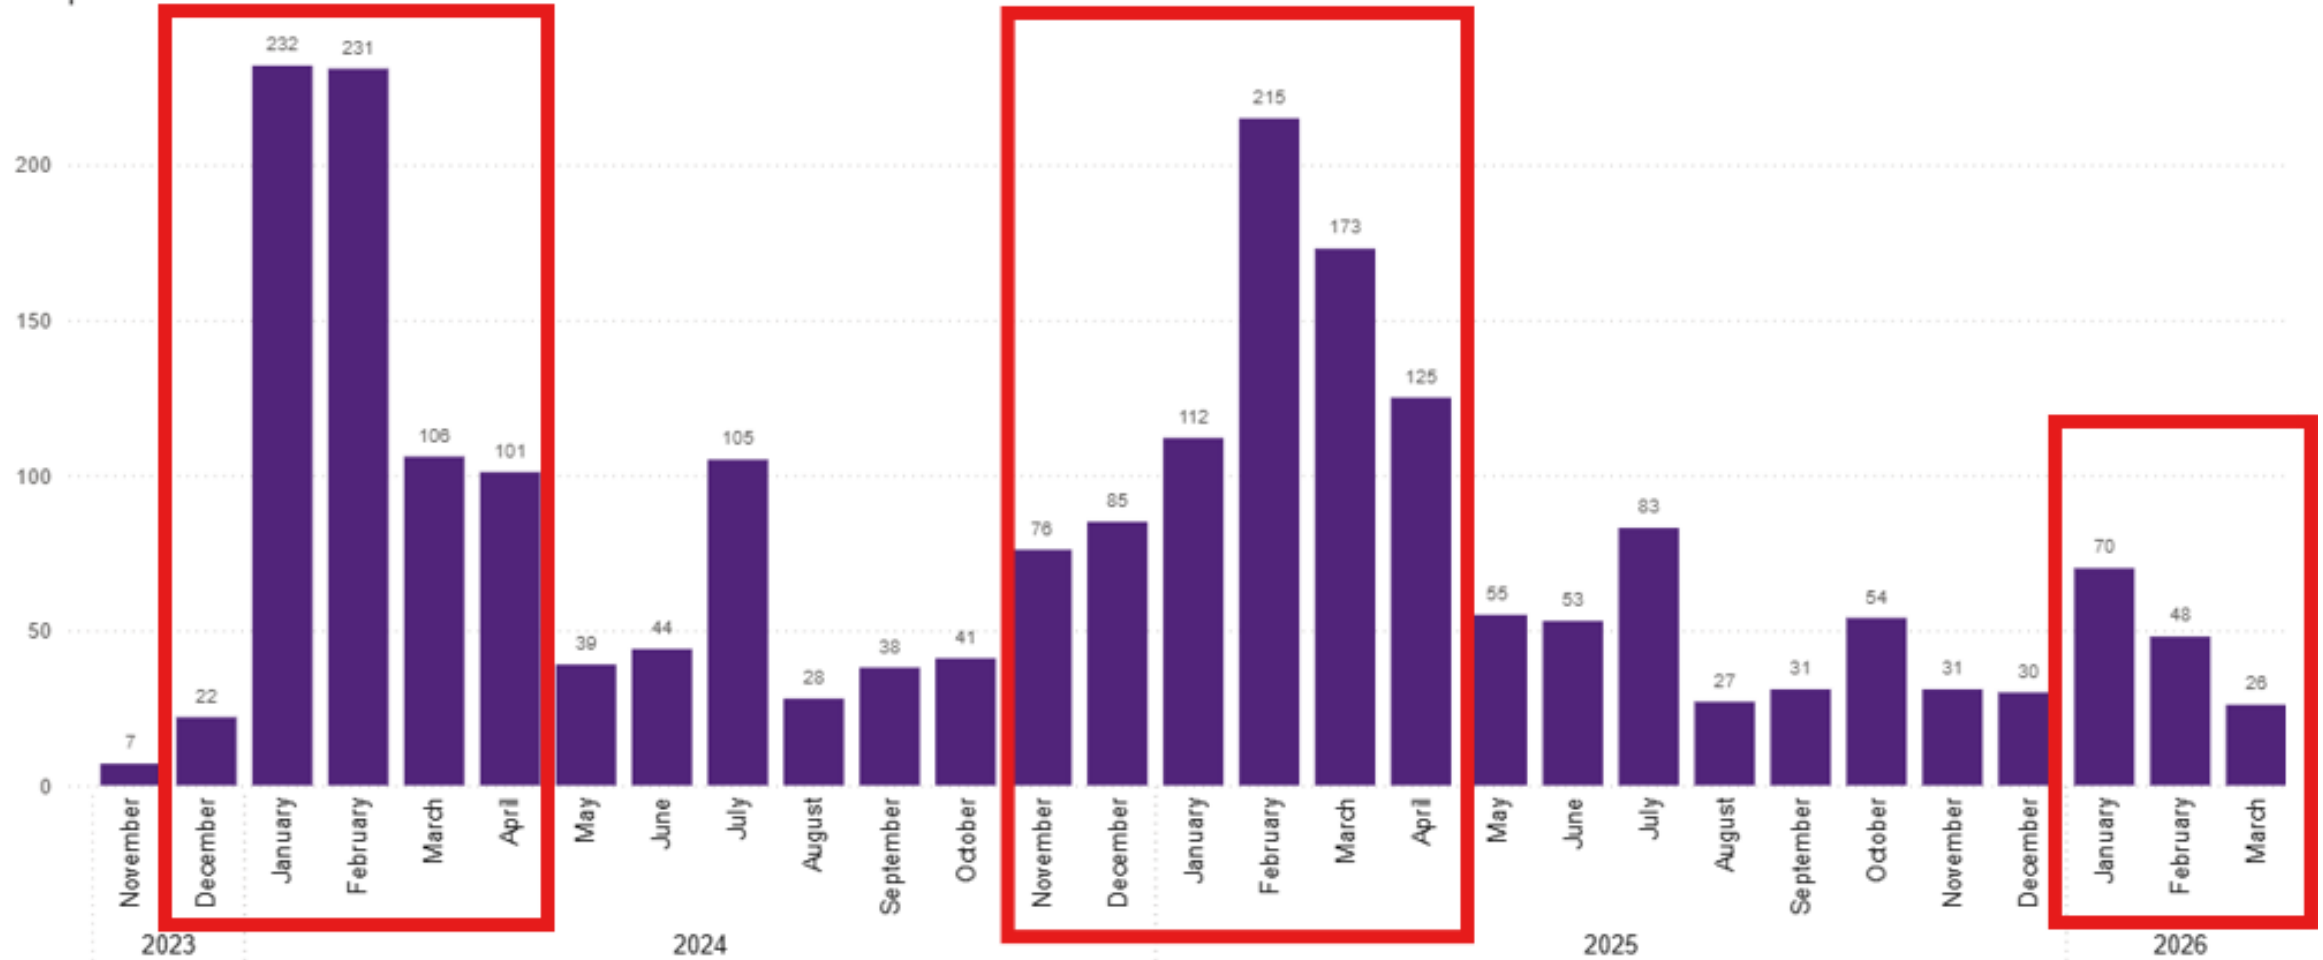
Requests over Time

Work Request Volume & Cost Trends

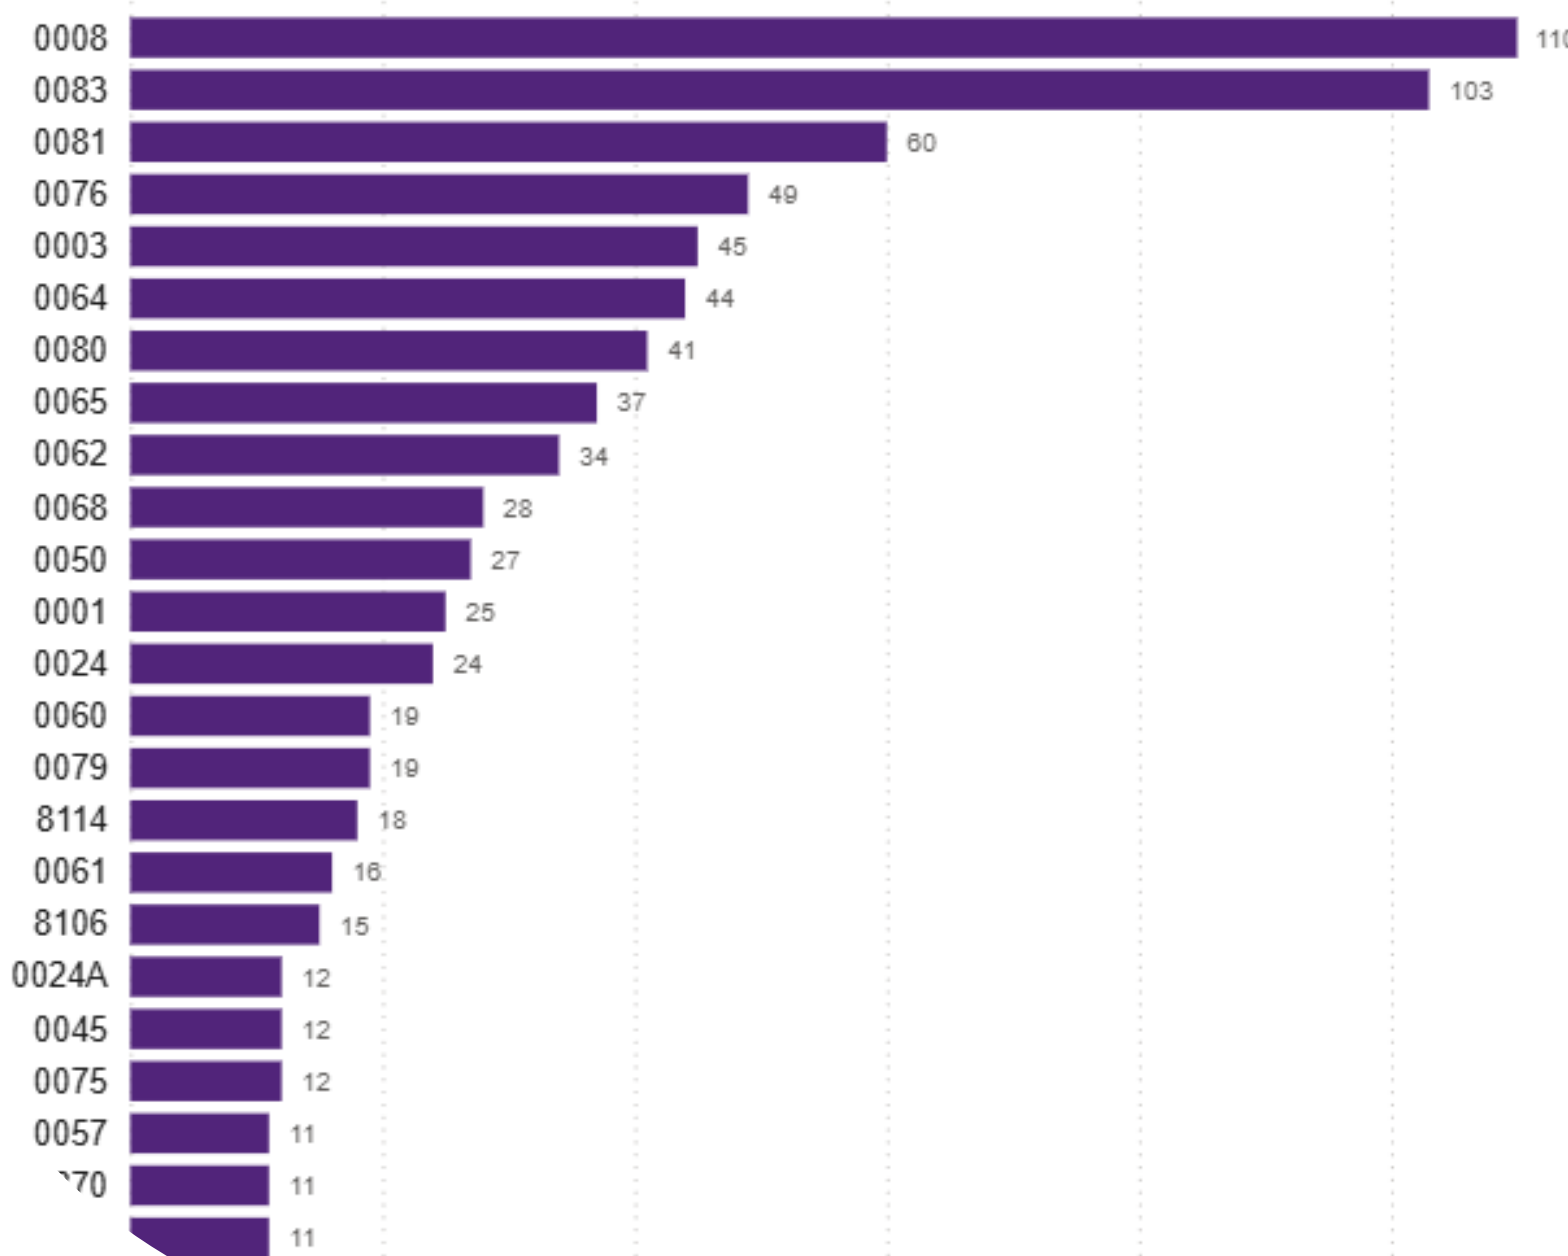
Work Request Volume Per Building

2024 – Top buildings of concern

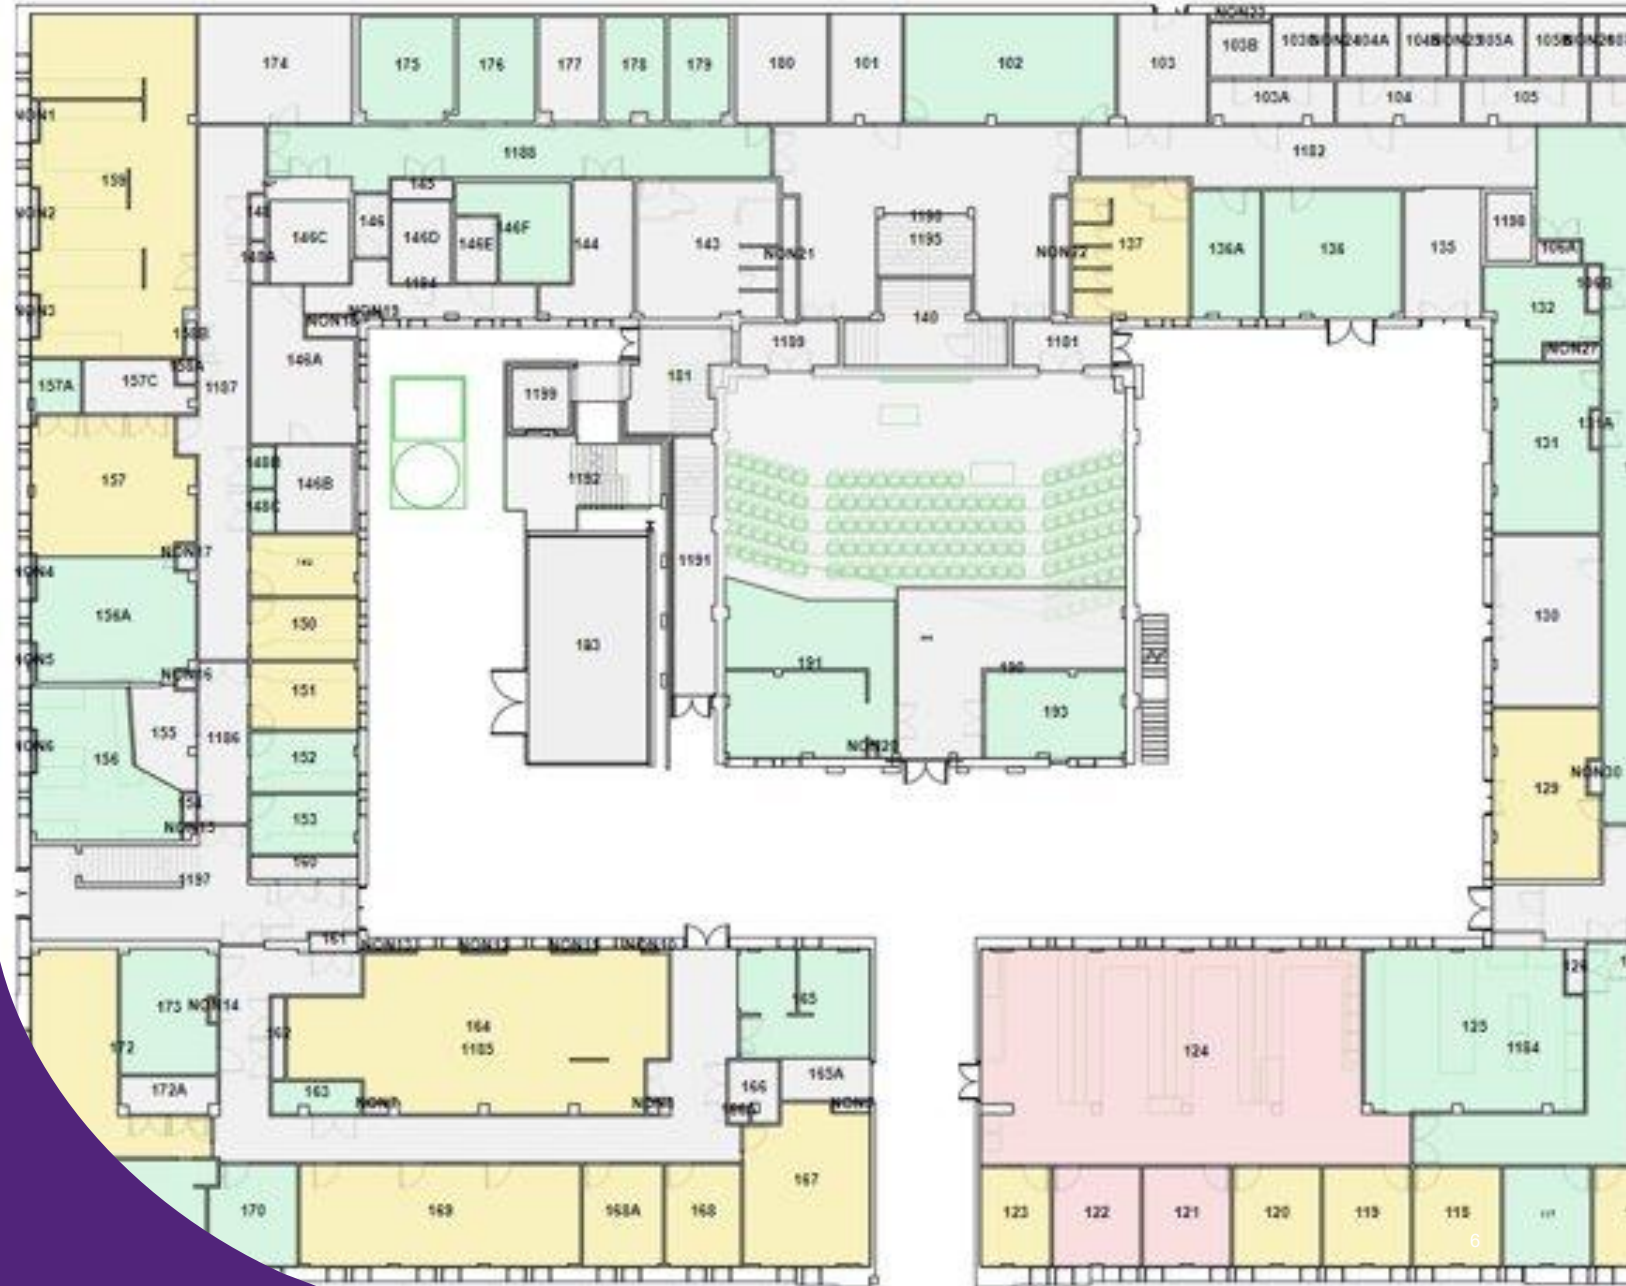
Narrowing down high frequency spaces

Heat maps used to visualise key impacted spaces to aid in both identification of local causes, and prevention via efficient HVAC grouping

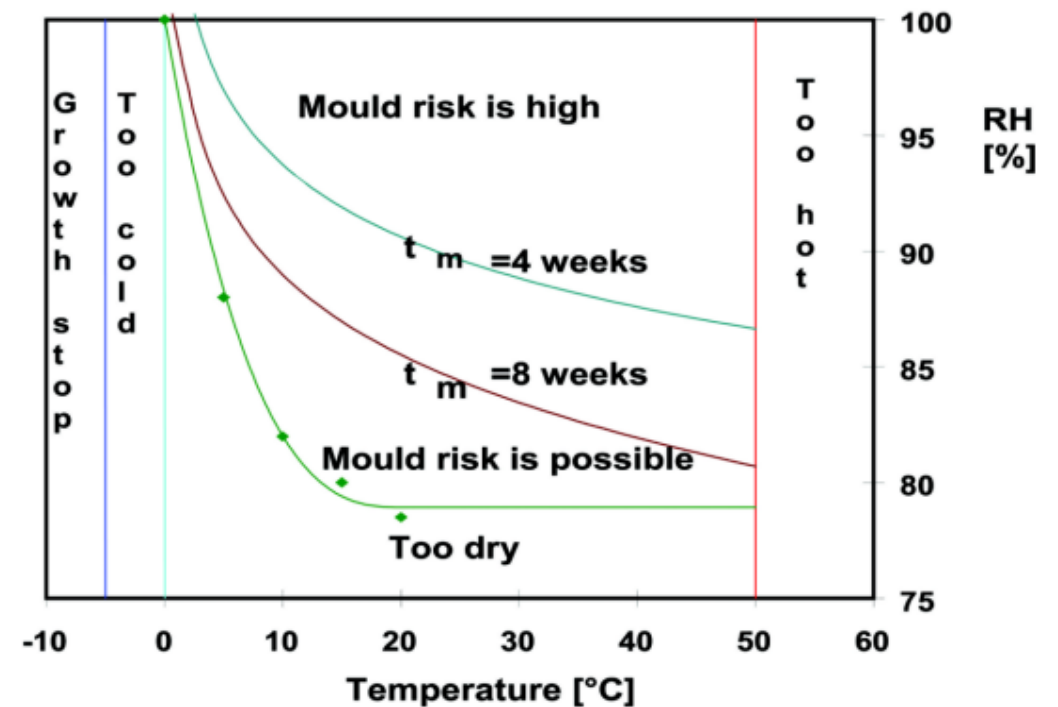
Mould growth is determined by four key factors: Water Activity (Humidity/dampness), Surface quality/contamination, temperature, and time in conditions.

Time in conditions

Temperature (0-50C)

Surface Quality

Water activity (Leaks/Humidity)

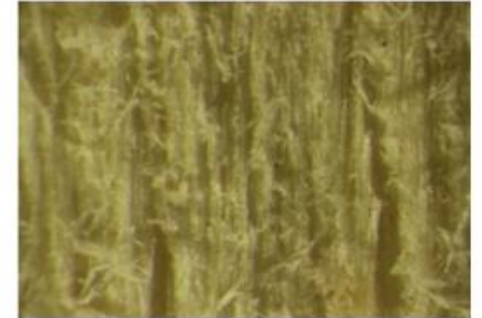
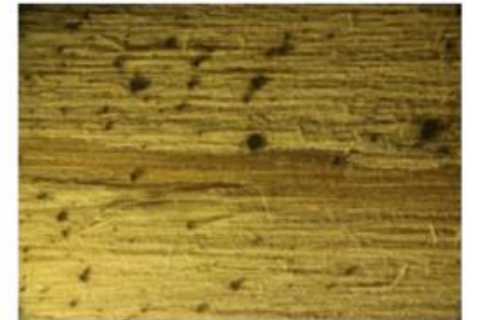
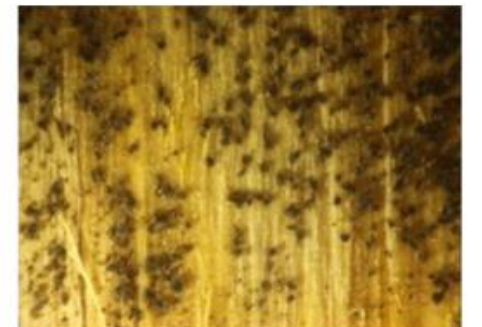
Mould Index definition

Index	Description of the growth rate
0	No growth
1	Small amounts of mould on surface (microscope), initial stages of local growth
2	Several local mould growth colonies on surface (microscope)
3	Visual findings of mould on surface, < 10 % coverage, or, < 50 % coverage of mould (microscope)
4	Visual findings of mould on surface, 10 - 50 % coverage, or, >50 % coverage of mould (microscope)
5	Plenty of growth on surface, > 50 % coverage (visual)
6	Heavy and tight growth, coverage about 100 %

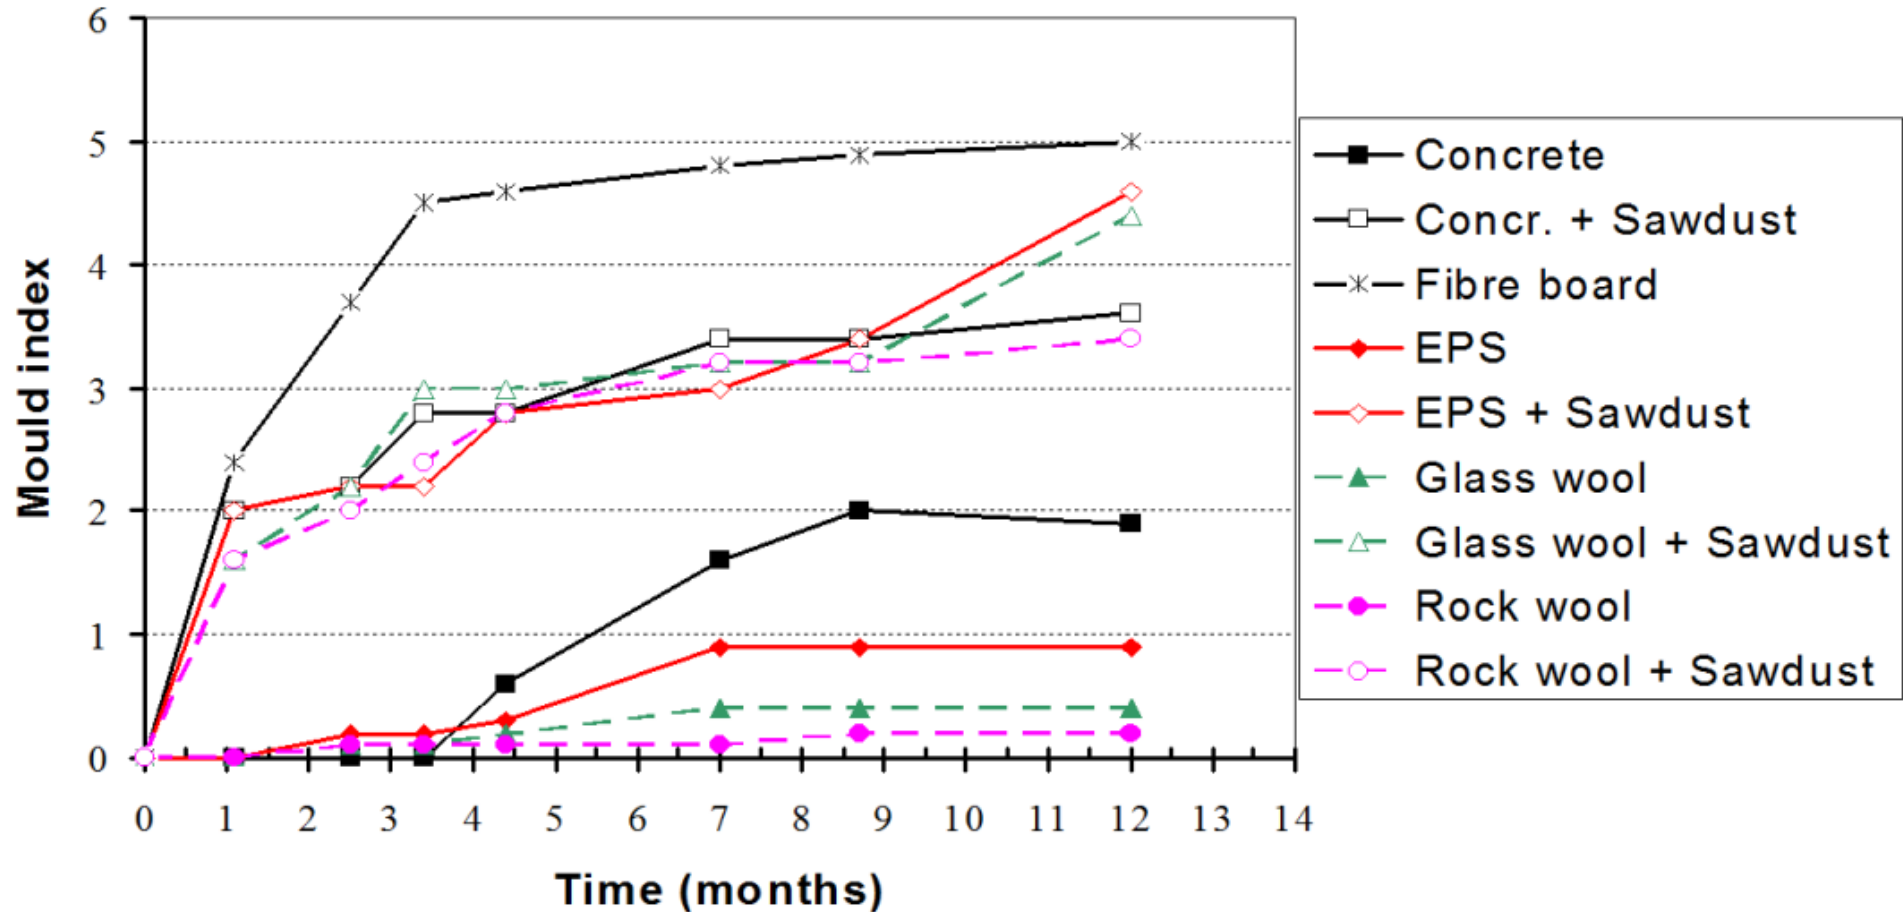
Impact of surface quality on building material

+20 C / 98 % RH conditions

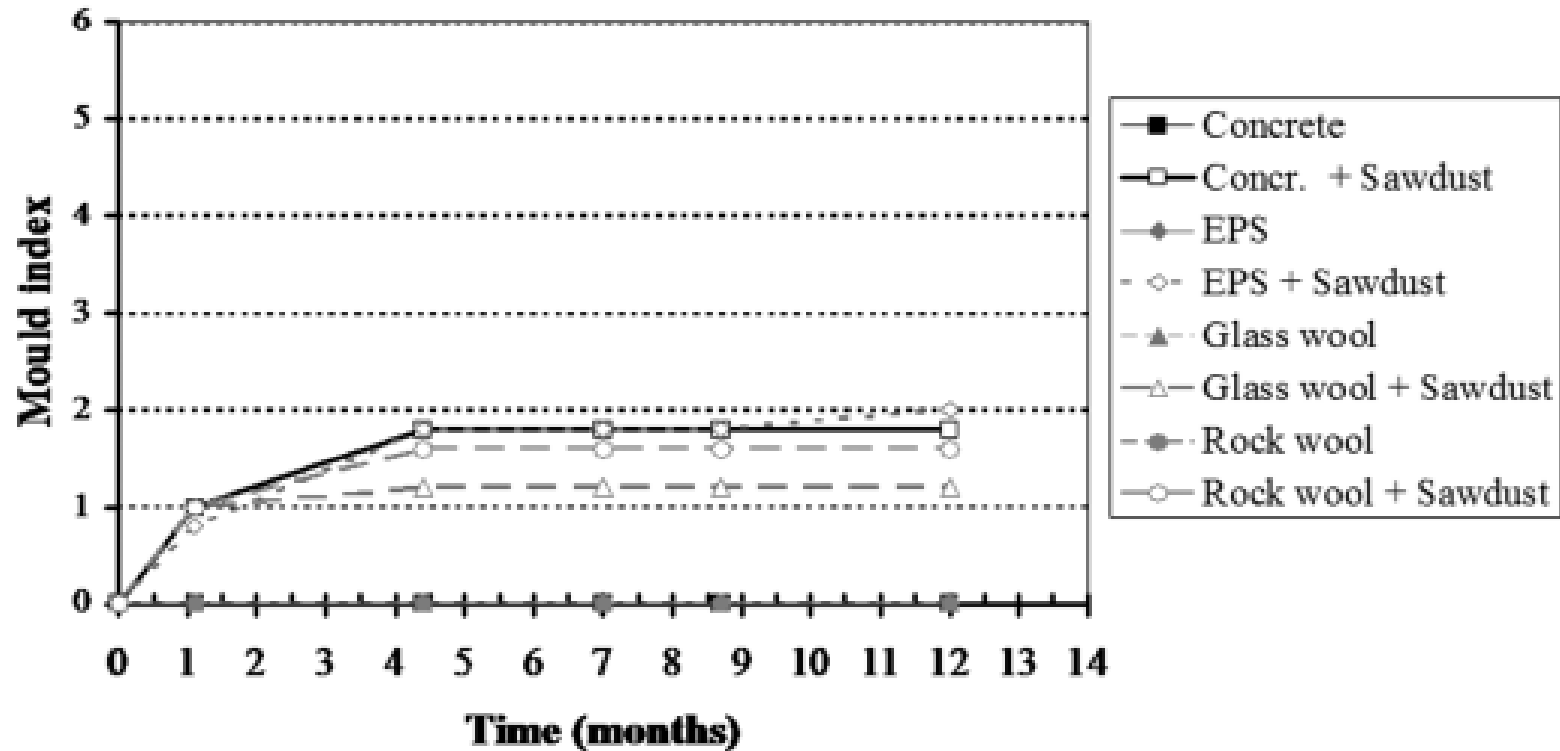
Impact of surface quality on building material

Open surface of materials, continual RH 88 - 90 %, T=20

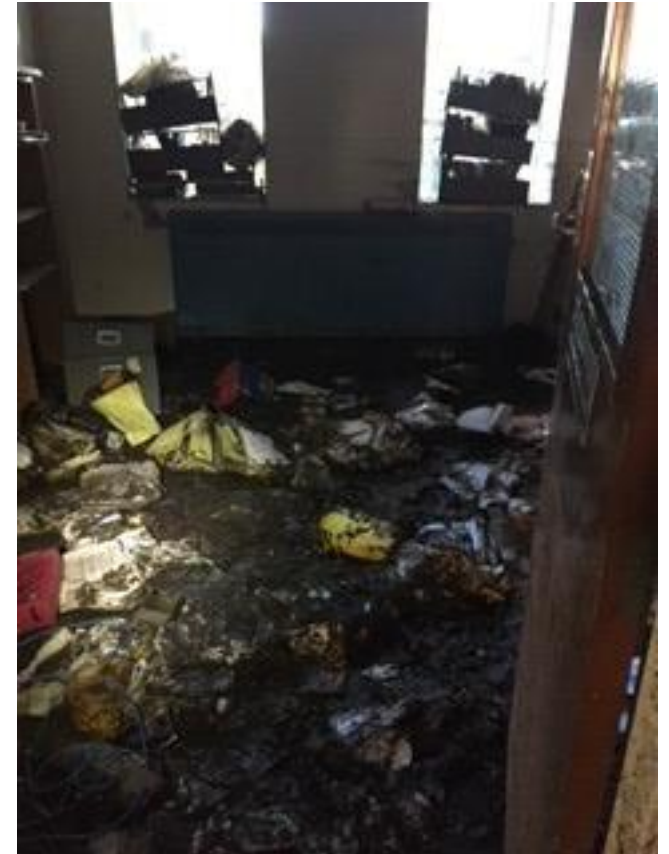
Lessons learned the importance of cutting wall linings at least 300mm above water line

- Removes saturated materials – Plasterboard and insulation hold moisture; cutting 300 mm above the waterline removes sections most likely to stay wet.

- Prevents long-term structural damage – Trapped moisture can cause timber framing to rot or corrode steel components over time. Opening the wall avoids future structural issues.

- Improves air circulation for dehumidifiers and fans – Creating a 300 mm opening allows equipment to effectively extract moisture from inside wall spaces.

- Ensures accurate assessment of hidden damage – Removing the lower section lets assessors check for swelling, distortion, or water damage to framing and services.

- Reduces risk of future odours and air-quality issues – Damp plasterboard and insulation can hold musty smells; removal prevents residual contamination.

- Aligns with industry best practice – Insurance, restoration, and building standards commonly recommend removing wall linings up to 300 mm above the highest water mark for flood-affected buildings.
